From Gases and Evaporators risk assessment towards an Integrated management of sea and land pollution incidents

Lessons learnt on past accidents involving ammonia, methanol, LNG and Li-ion batteries

31/03/2025

Work Package 3

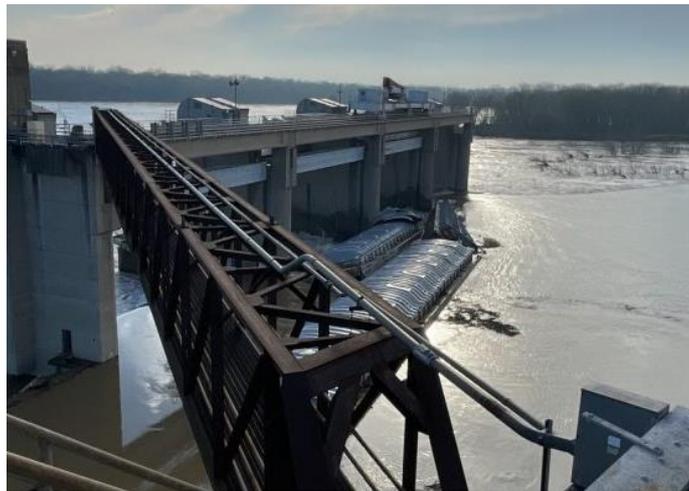
On 28 March 2023, a barge loaded with 1,400 tons of methanol was among those to have crashed on the Ohio River near Louisville, Kentucky. This happened after that 10 out of 11 barges separated from a tugboat that collided with a "stationary structure" at the entrance to the Portland Canal, according to The Louisville Metropolitan Emergency Services (LMES). Seven of the barges contained loads of corn, while two contained soybean oil residues, and one contained methanol. The barge loaded with methanol was among the ones pinned against the McAlpine Locks and Dam (Figure 1) and partially submerged in the river.

Figure 1. Submerged barges pinned against the McAlpine Locks and Dam on the Ohio River near Louisville, Kentucky (Image: Via the Kentucky Energy and Environment Cabinet Twitter account).
